Division of Oil, Gas & Mining

Inspection Report

Minerals Regulatory Program

Mine Name: ML 27618	Permit Number: S/025/0025
Operator Name: Althea Crapo & Russ Henry	Inspection Dates: October 18, 2012; November 27, 2012
Inspector(s): Peter Brinton	Time: afternoon (Oct 18) & evening (Nov 27)
Other Participants: Paul Baker	Mine Status: Active

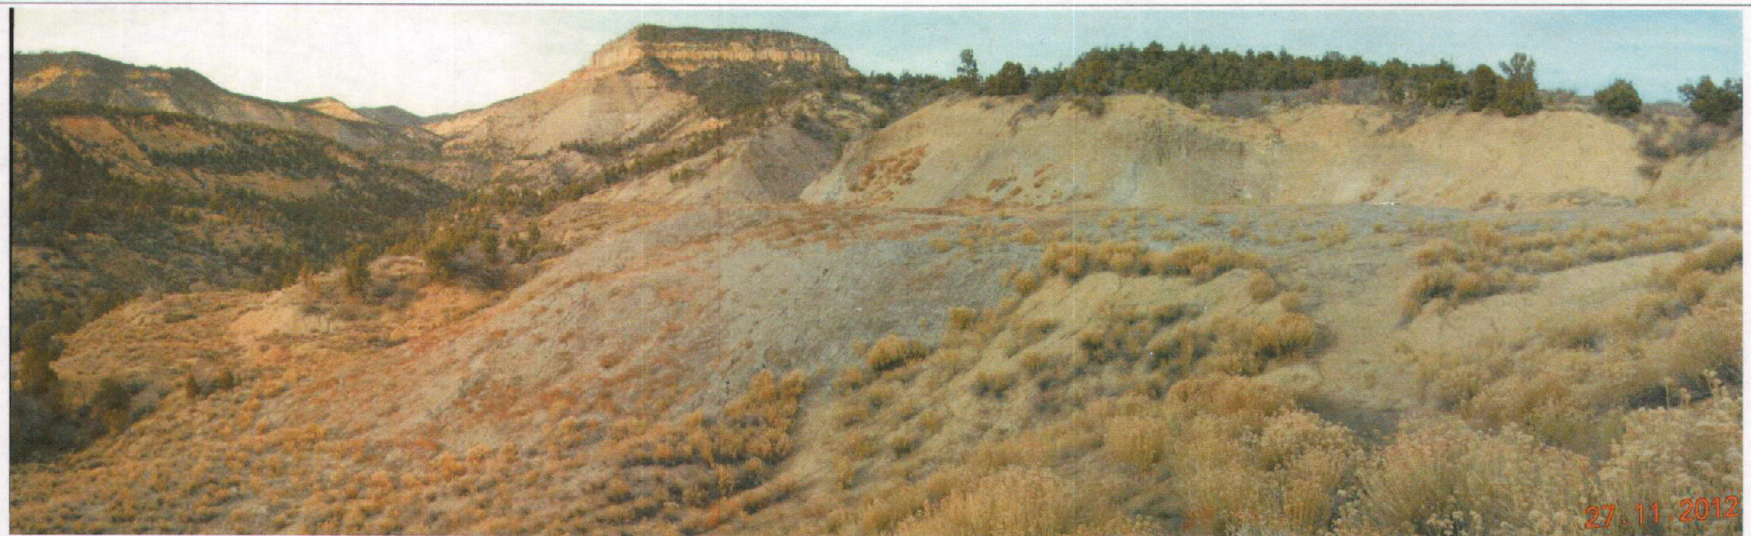
The bare, less-vegetated slopes in Trail Canyon area of the permit remained unstable. No large-scale slumping had occurred since the dozer earthwork. Tension cracks at the crest and on the slope were again observed, and some degree of ongoing slumping is expected. It appeared that rabbitbrush was beginning to establish on these slopes, which were covered with Russian thistle skeletons and another unidentified plant.

Trail Canyon: Stitched photo of partially-reworked dump and highwalls. No recent slumping is obvious. Bare slopes with natural erosion and instability are visible up the canyon.

The dump slopes in Trail Canyon and in the east area (ML51615) remain unstable, and it is recommended that dump slopes not be fully released from the permit at this point. The Division will continue to evaluate stability.

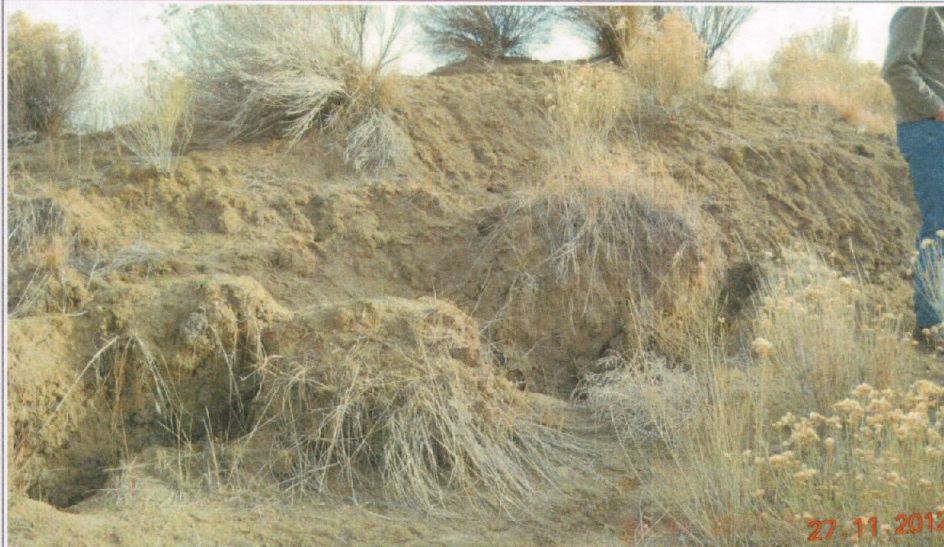
In November, the rabbitbrush-covered dump slopes to the south of the Russian thistle-covered slope were inspected more closely for signs of instability, and significant slumping and fairly recent movement were more clearly documented. At least one slide scarp in this area measured about 4 feet tall, and multiple large tension cracks (up to about 18 inches wide) were present near the top of the slope. Tension cracks were observed on the revegetated dumps to the north of the less-vegetated dumps in past inspections.

Trail Canyon: Slide scarp (~ 4 feet high) on revegetated dumps, south of less-vegetated dumps.

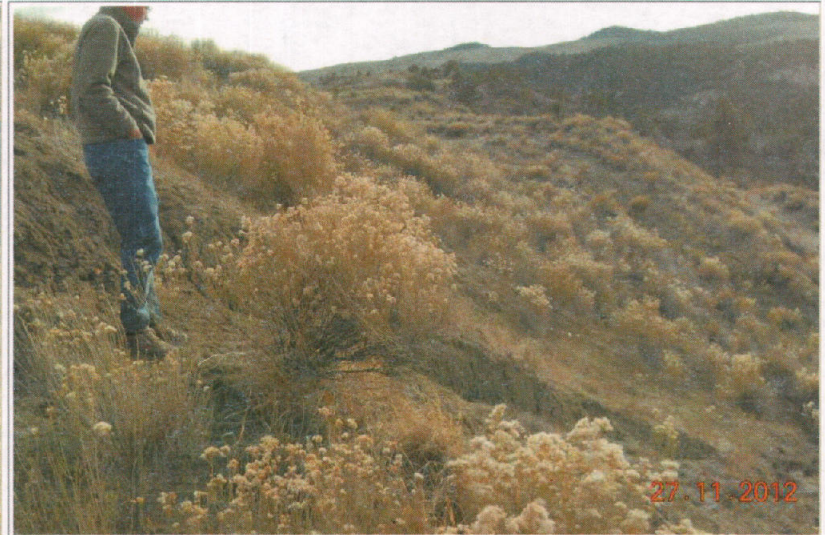
Trail Canyon: Slide scarp on revegetated dumps continuing down the hill.

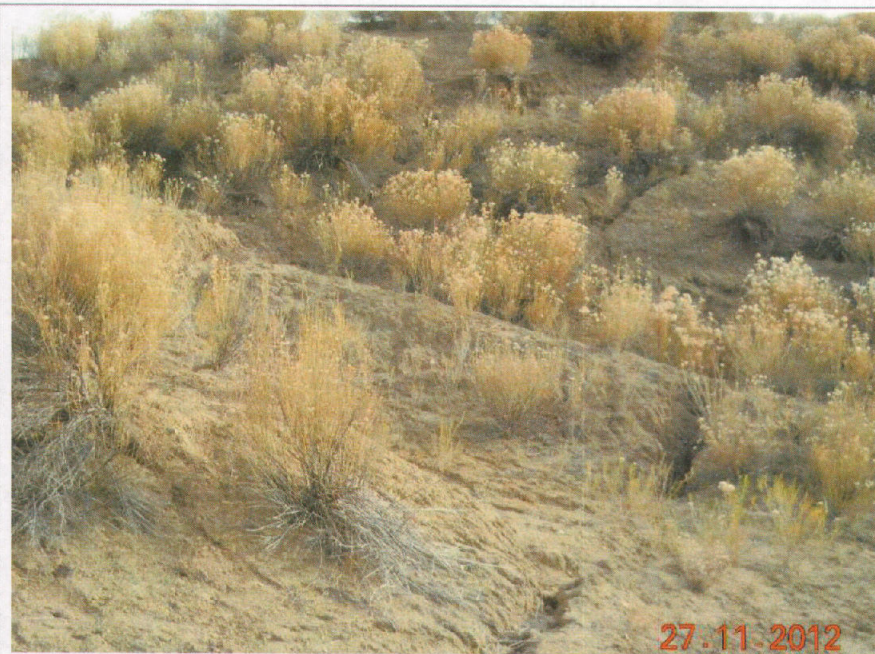
Trail Canyon: Scarp (from left to upper center) and cracks on a re-vegetated south dump.

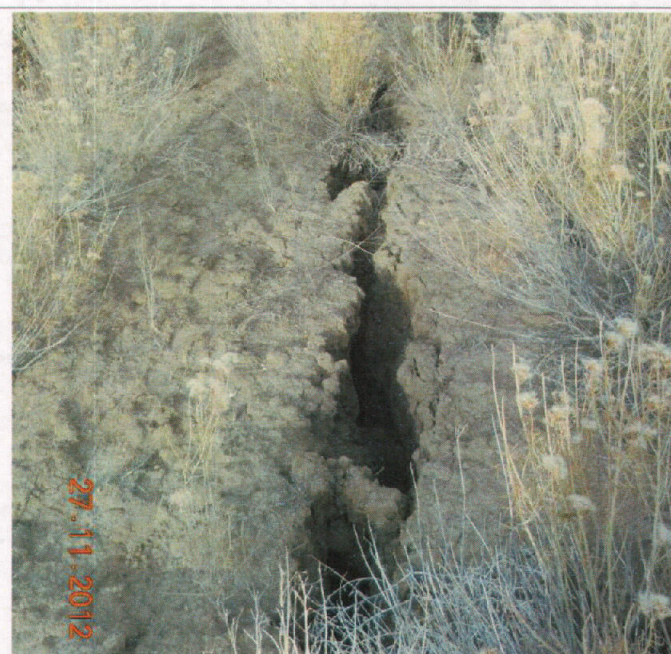
Trail Canyon: Example of a fairly fresh tension crack.

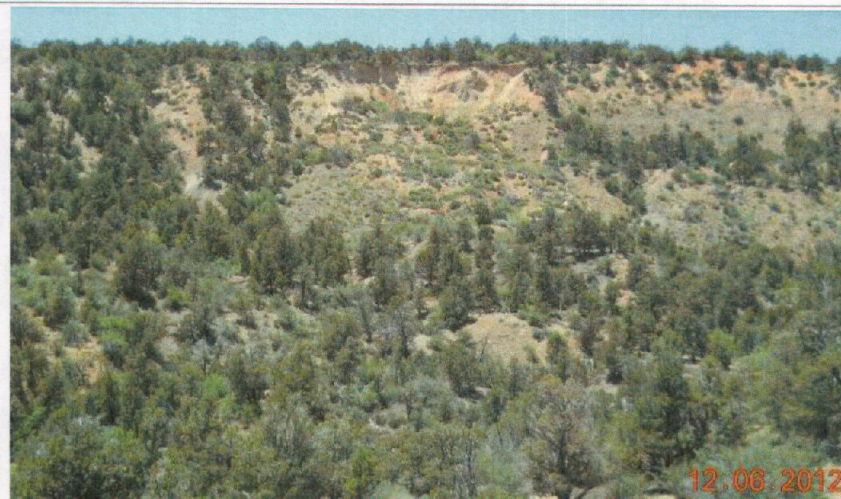
Instability and slumping is observed on natural slopes in Trail Canyon. See the June 6, 2012 photo included below.

Trail Canyon: Large-scale natural failure north and opposite of mines in Trail Canyon.

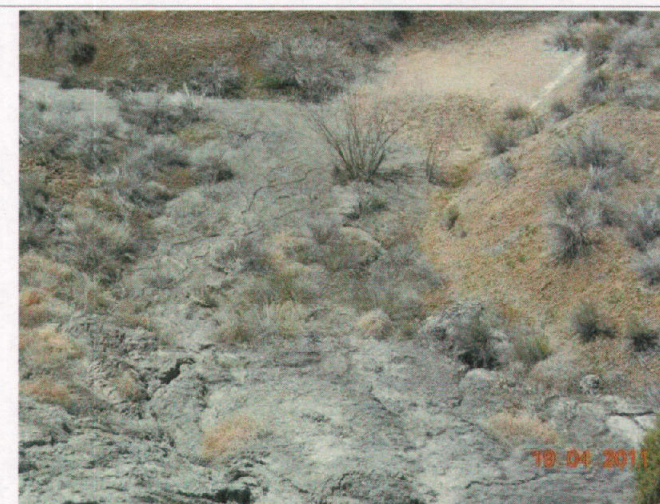
to drain ponded water below the highwall) resulted in sedimentation of gray material in a channel below the dump. This erosion does not appear to have significantly impacted vegetation. It is expected that this channel will continue to erode and deposit sediment downstream during significant runoff. See the 2011 photo included below.

Trail Canyon: 2011 erosion below drainage cut in the barer dump.

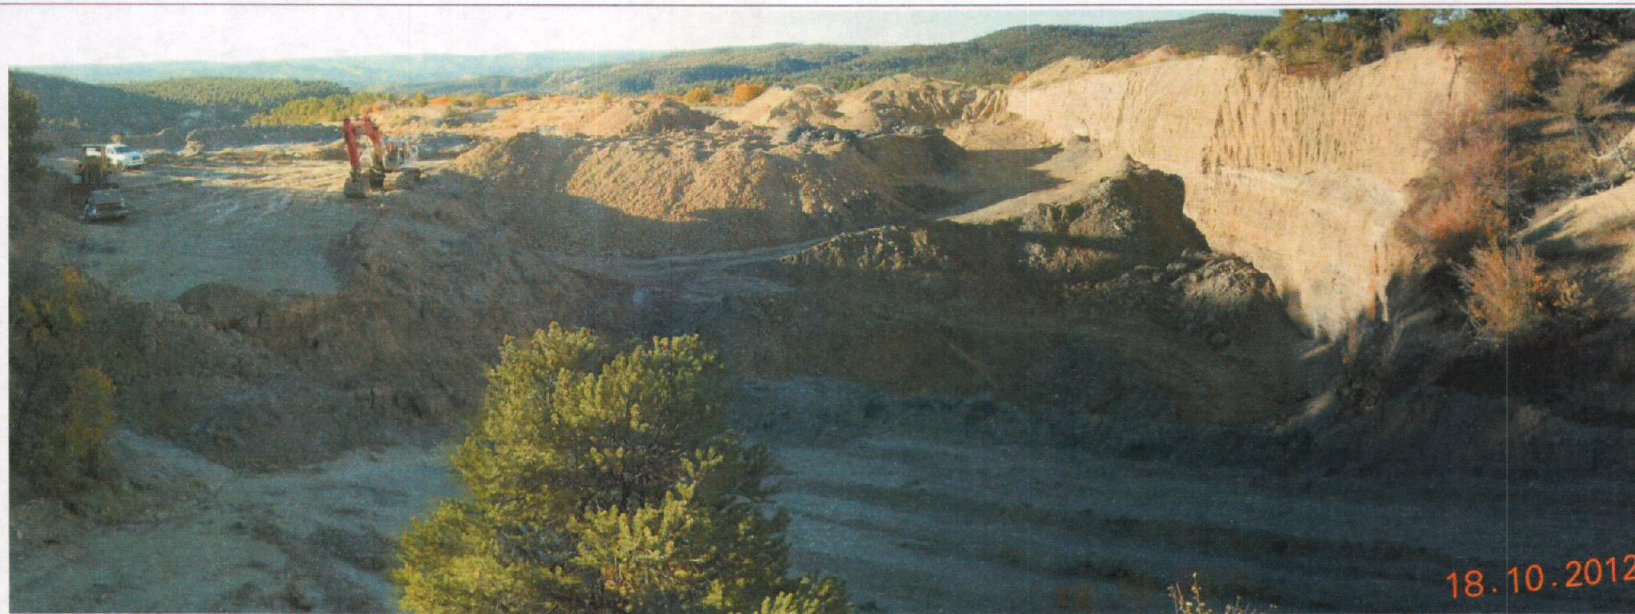
On October 18th, the disturbed area was measured to be about 4 acres using a Trimble GPS unit. It was observed that significant expansion of the east area pit had occurred, including the re-disturbance of areas to the south that had been regraded. Part of the central pit has been partially backfilled using overburden from the adjacent pit excavation. The estimated maximum highwall height on the north end of the pit was 70 feet in October. A bench was present on the shallower, south end of the pit. A tall berm was in place above most of the highwall, and trees and brush were present above much (but not all) of the tallest part of the highwall. Raveling on the highwall was heard. Some minor sub-surface flow (likely from the drainage) was seeping from the pit highwall.

East Area: Stitched photo showing the pit, looking south. Note the berm above most of the visible highwall. The filled / mined drainage is in the foreground and to the left.

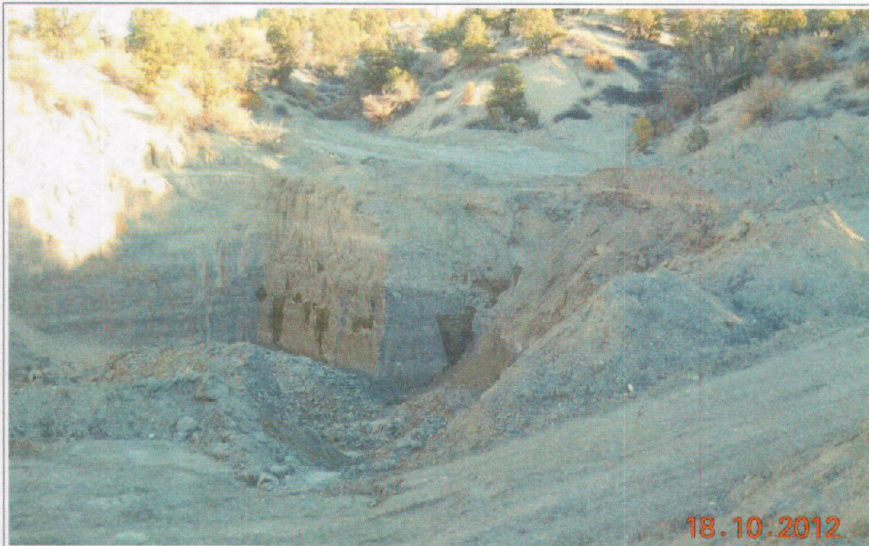
East Area: Seepage from the highwall, likely from filled drainage behind, looking north.

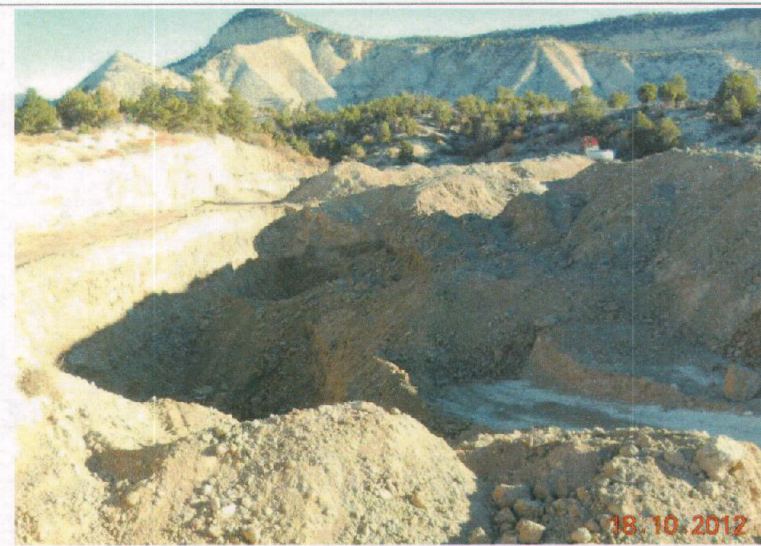
East Area: South area of pit, with bench and backfill. Past regrading was re-mined.

The east area reclamation will be inspected in 2013, and any appropriate actions will be taken then. The Notice of Intent will need to be updated to identify future mining areas, for which cultural resource evaluation is needed. The Notice also needs to be updated to identify the current authorized officer for the permit.

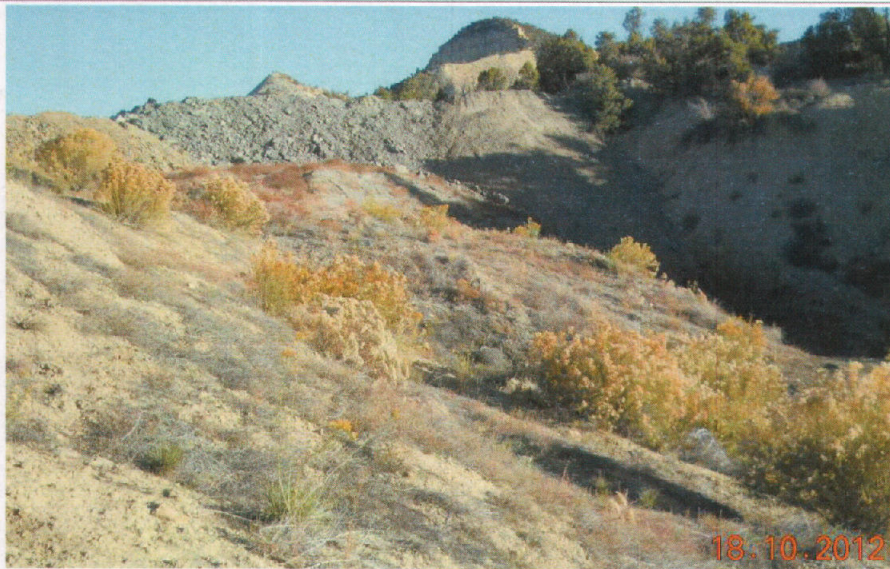
Dumps had been expanded further up and down the drainage and to a greater depth since the last inspection. No ponded water was observed. As with the Trail Canyon dumps, tension cracks were observed on the older dumps in the east area, on which good coverage of rabbitbrush and Indian rice grass were growing.

East Area : New and older (vegetated) dumps in the drainage from below, looking north.

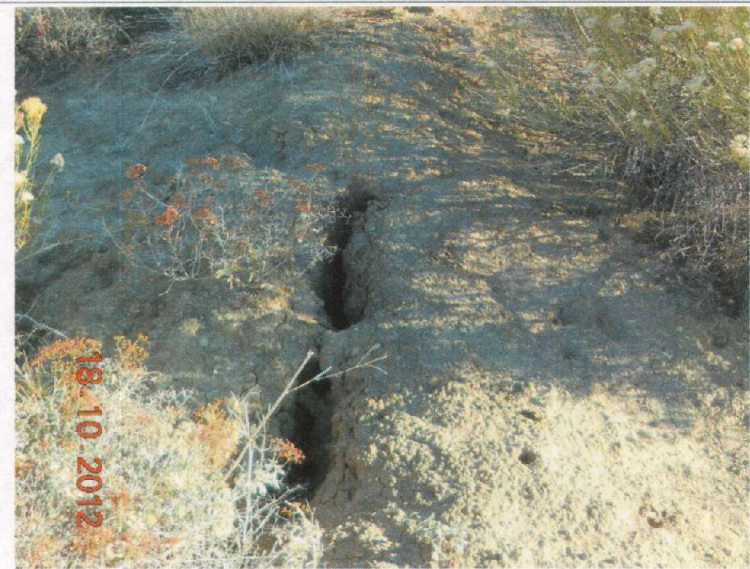
East Area : Crack on a revegetated slope.

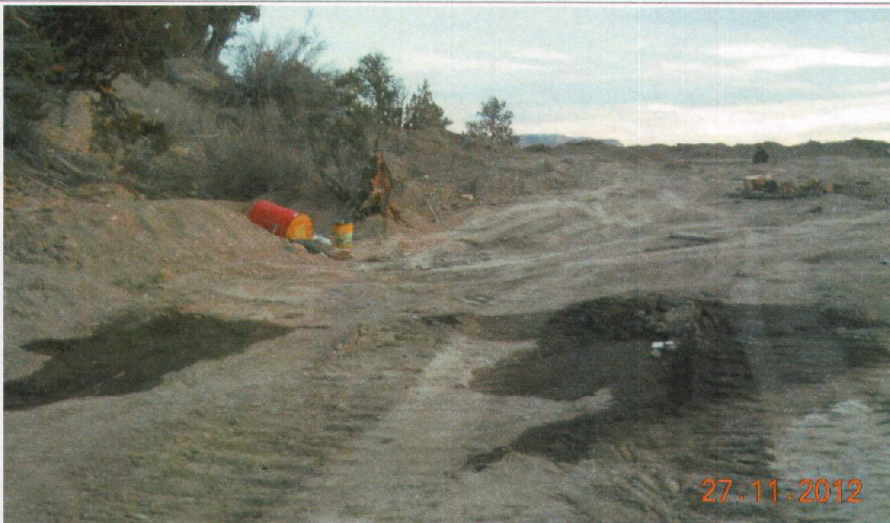
On November 27th, some additional mining activity had taken place, but the highwall appeared the same in height, at least on the north end of the pit. Some equipment had been removed. No water was observed seeping from the highwall. Oil spills were observed on graded dump material in the general area where equipment had been parked. Some trash remained.

East Area: Spilled oil locations and remaining trash.

The operator has recently allowed spills of oil or other fluids at the east area, and needs to do a better job of containing oil or other fluids, and should appropriately dispose of fluids offsite.

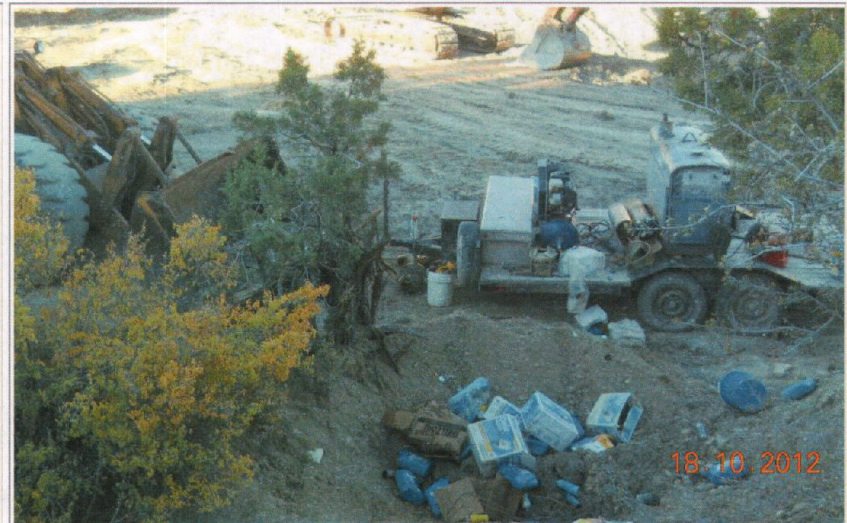
Excavating and other equipment were onsite. Trash at the site was consolidated into one area.

East Area: Equipment and consolidated (but loose) trash.
